magicolor[®] 330

Service Manual

November 2000
1750049-001B

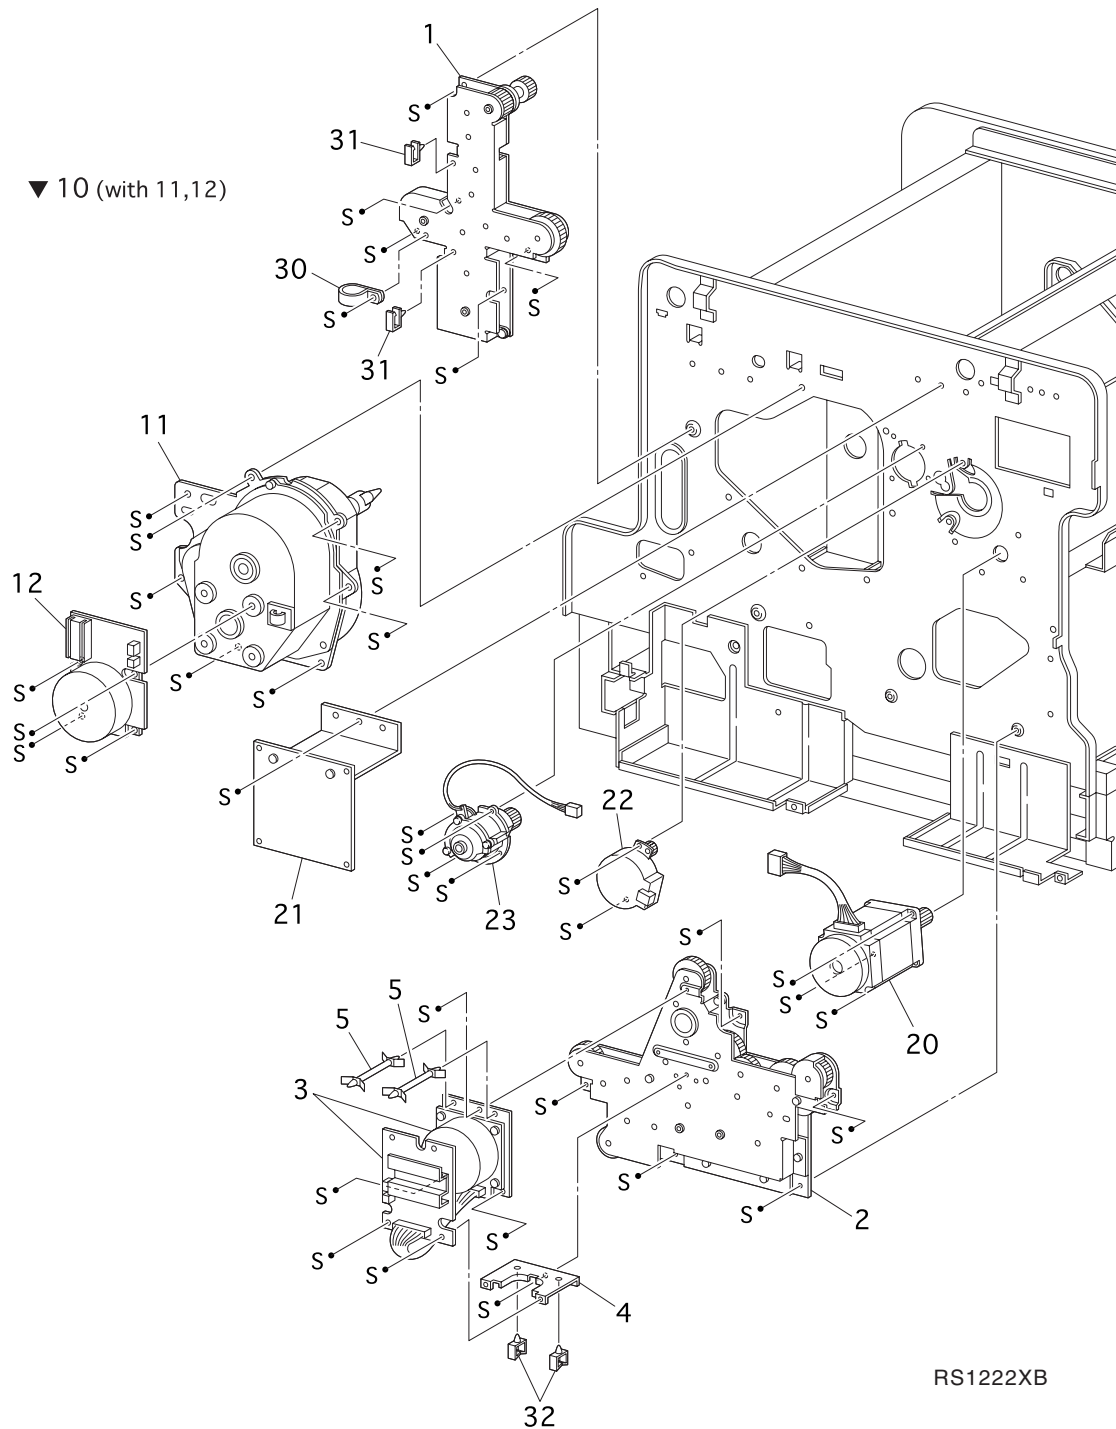
PL11.1 Drive

1. P/H DRIVE ASSEMBLY	P/N 865007K84580
2. FUSER DRIVE ASSEMBLY	P/N 865007K83603
3. P/H MOTOR ASSEMBLY	P/N 865600K68650
4. P/H MOTOR BRACKET	N/A
5. P/H MOTOR SUPPORT	N/A
10. PROCESS DRIVE ASSEMBLY (with 11 and 12)	P/N 865127K24661
11. PROCESS WDD ASSEMBLY	N/A
12. PROCESS MOTOR ASSEMBLY	N/A
20. ROTARY MOTOR ASSEMBLY	P/N 865127K21171
21. ROTARY MOTOR PWB	P/N 865160K38740
22. DISPENSE MOTOR ASSEMBLY	P/N 865127K16311
23. DEVELOPER CLUTCH ASSEMBLY	P/N 865121K87716
30. DRIVE CLAMP-N	N/A
31. DRIVE CLAMP-Y	N/A
32. DRIVE CLAMP-W	N/A

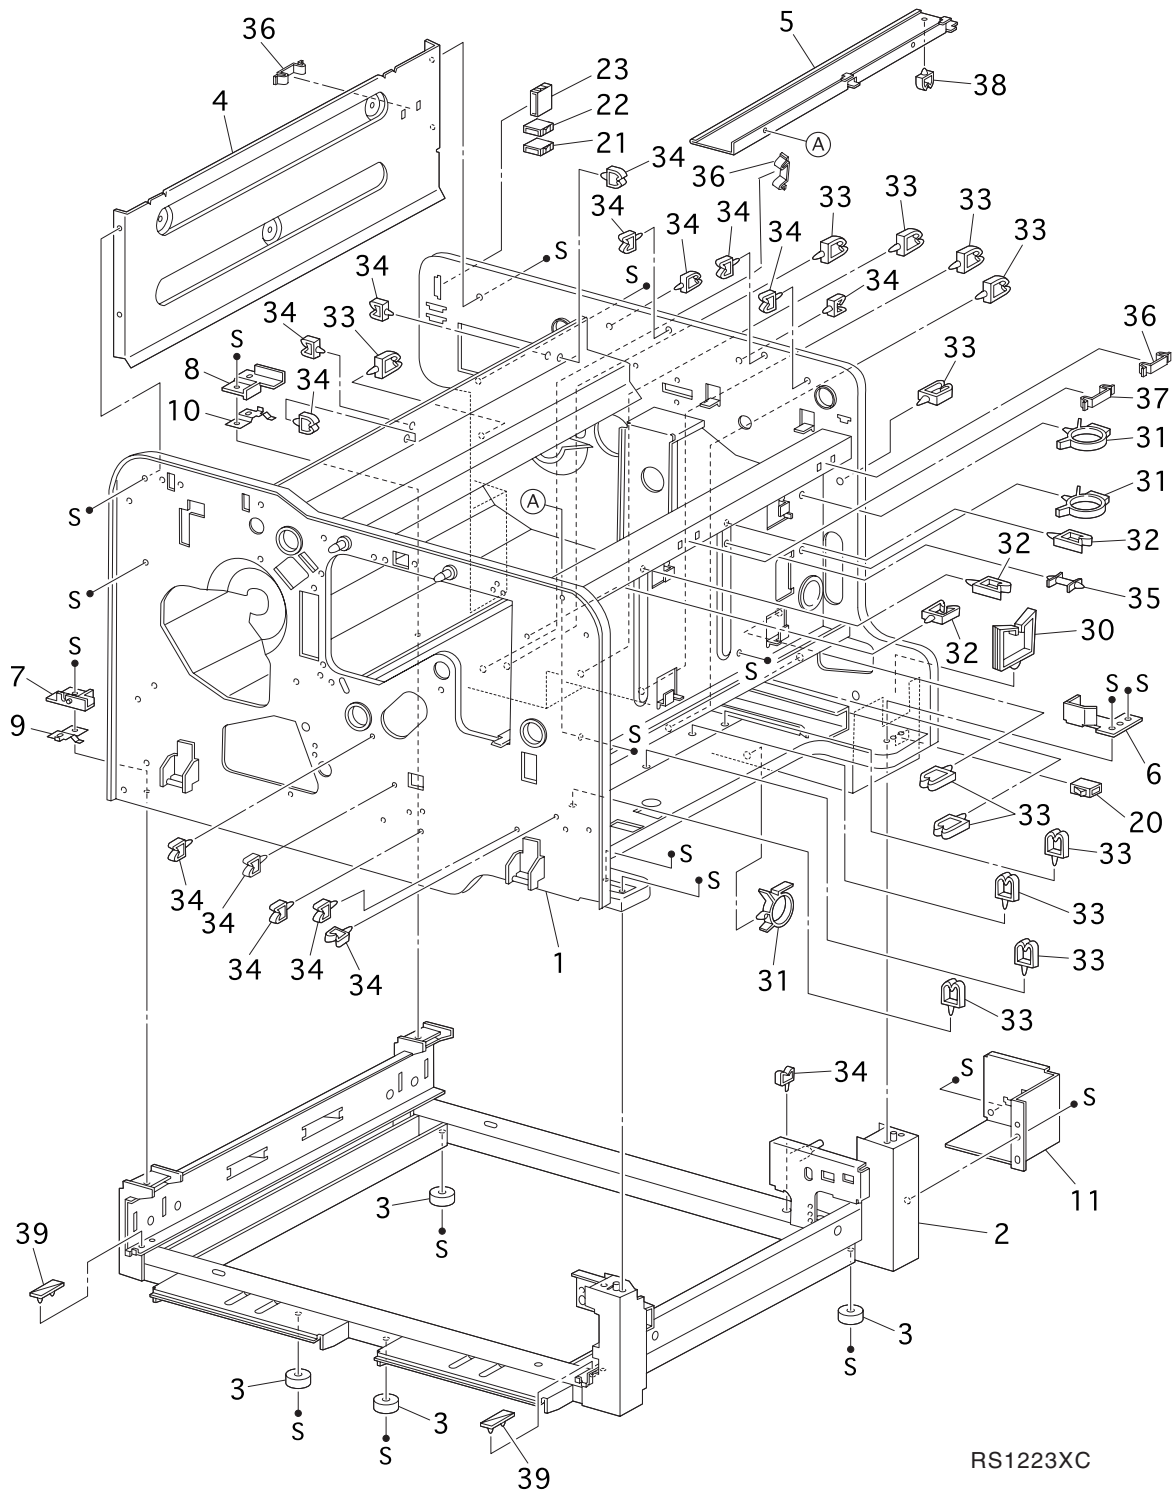
PL12.1 Frame

1. BASE FRAME ASSEMBLY	N/A
2. FEEDER FRAME ASSEMBLY	N/A
3. FRAME FOOT	N/A
4. DEVELOPER TIE PLATE.....	N/A
5. CATCH PLATE	N/A
6. P/H GUIDE BRACKET	N/A
7. FUSER FRONT GUIDE	N/A
8. FUSER REAR GUIDE.....	N/A
9. FUSER FRONT SPRING	N/A
10. FUSER REAR SPRING	N/A
20. FEEDER CONNECTOR-2P	N/A
21. EXIT CONNECTOR-3P	P/N 865913W01205
22. EXIT CONNECTOR-4P	P/N 865913W01227
23. EXIT CONNECTOR-8P	P/N 865913W01210
30. EDGE SADDLE-U.....	N/A
31. FRAME CLAMP-R.....	N/A
32. FRAME CLAMP-L.....	N/A
33. FRAME CLAMP-M.....	N/A
34. FRAME CLAMP-S	N/A
35. PWB SUPPORT	N/A
36. FRAME CLAMP-PS.....	N/A
37. FRAME CLAMP-PL.....	N/A
38. FRAME CLAMP-U	N/A
39. SHEET CLAMP	P/N 865019E345000

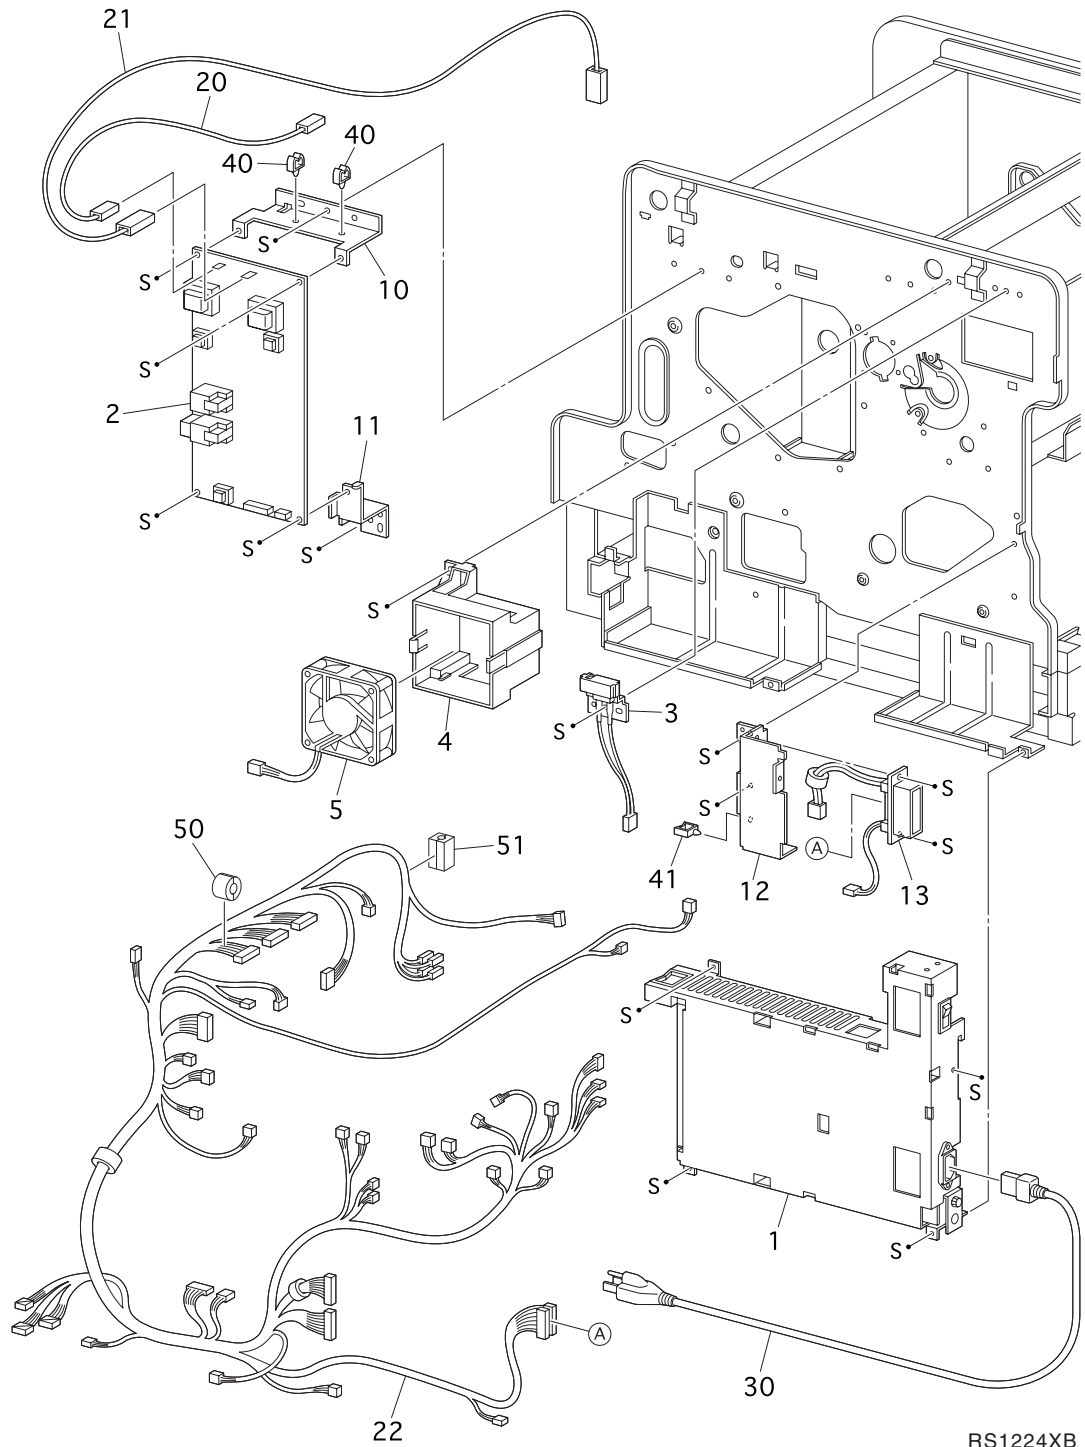
PL13.1 Electrical I

1. LVPS-110V	P/N 865105K14351
1. LVPS-220V	P/N 865105K94971
2. HVPS	P/N 865105K11871
3. TOP COVER SWITCH	P/N 865110K98810
4. FAN DUCT	N/A
5. DEVELOPER FAN	P/N 865127E81301
10. HVPS BRACKET-1	N/A
11. HVPS BRACKET-2	N/A
12. CONNECTOR BRACKET-F	N/A
13. FUSER CONNECTOR	P/N 865162K25462
20. BCR WIRE	N/A
21. DEVELOPER WIRE	N/A
22. MAIN HARNESS ASSEMBLY	P/N 865162K16124
30. POWER CORD	N/A
40. ELECTRIC CLAMP-S	N/A
41. ELECTRIC CLAMP-M	N/A
50. FERRITE CORE-M1	N/A
51. FERRITE CORE-M2	N/A

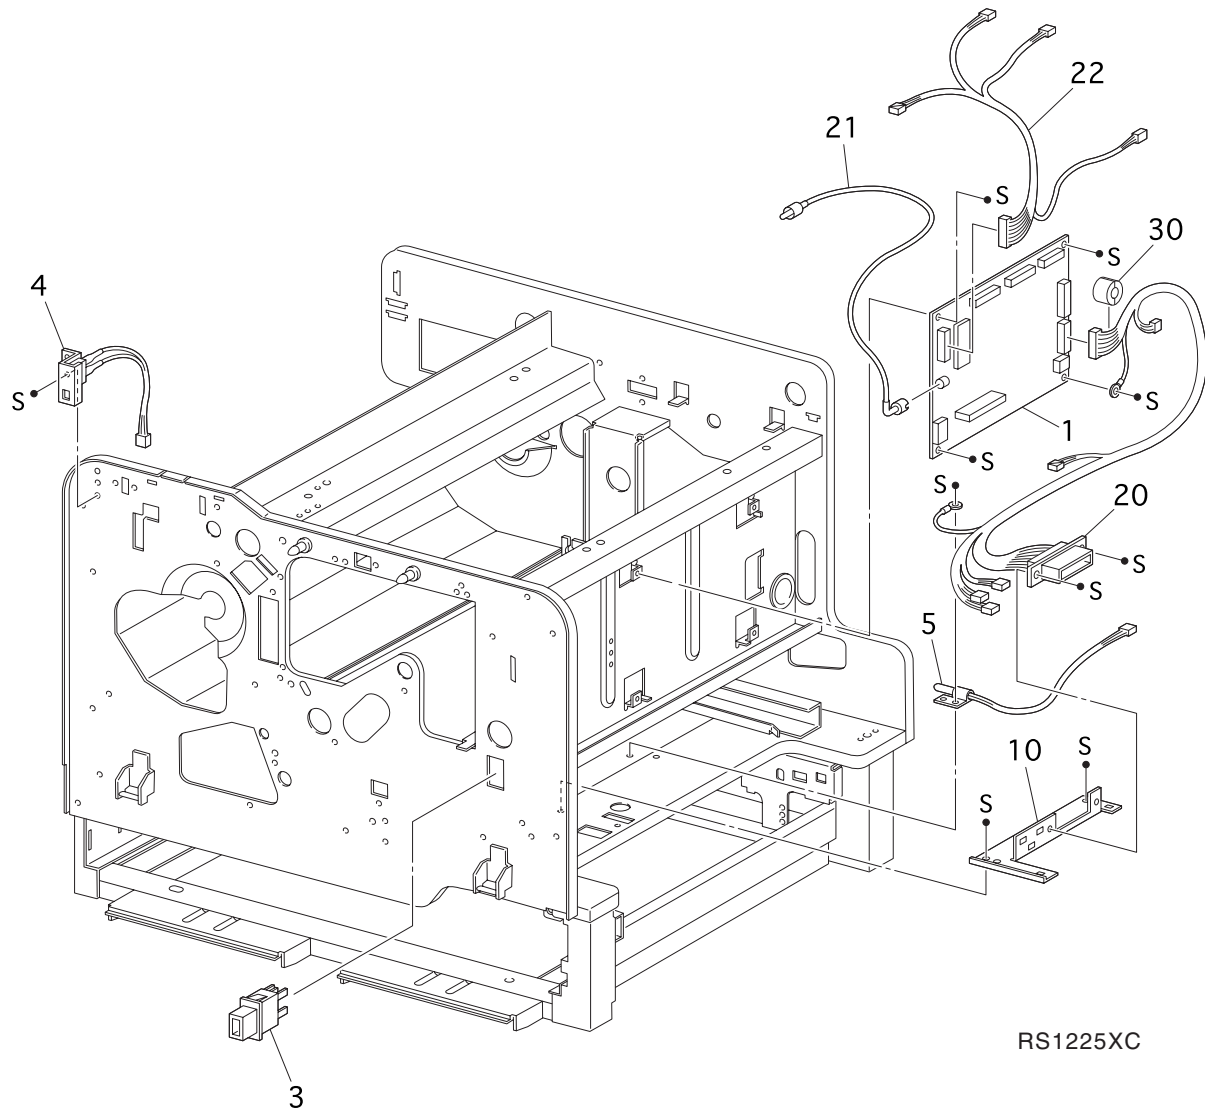
PL13.2 Electrical II

1. MCU PWB (with ROM).....	P/N 865160K52321
1. MCU PWB (no ROM).....	P/N 865160K59151
2. MCU ROM	P/N 865537K50872
3. FRONT COVER SWITCH R.....	P/N 865110K07831
4. FRONT COVER SWITCH L.....	P/N 865110K08280
5. ENVIRONMENT SENSOR.....	P/N 865130K87550
10. CONNECTOR BRACKET-P.....	N/A
20. P/H HARNESS ASSEMBLY	P/N 865162K16221
21. VIDEO HARNESS.....	P/N 865162K16421
22. ROS HARNESS	P/N 865162K16134
30. FERRITE CORE-P1	N/A

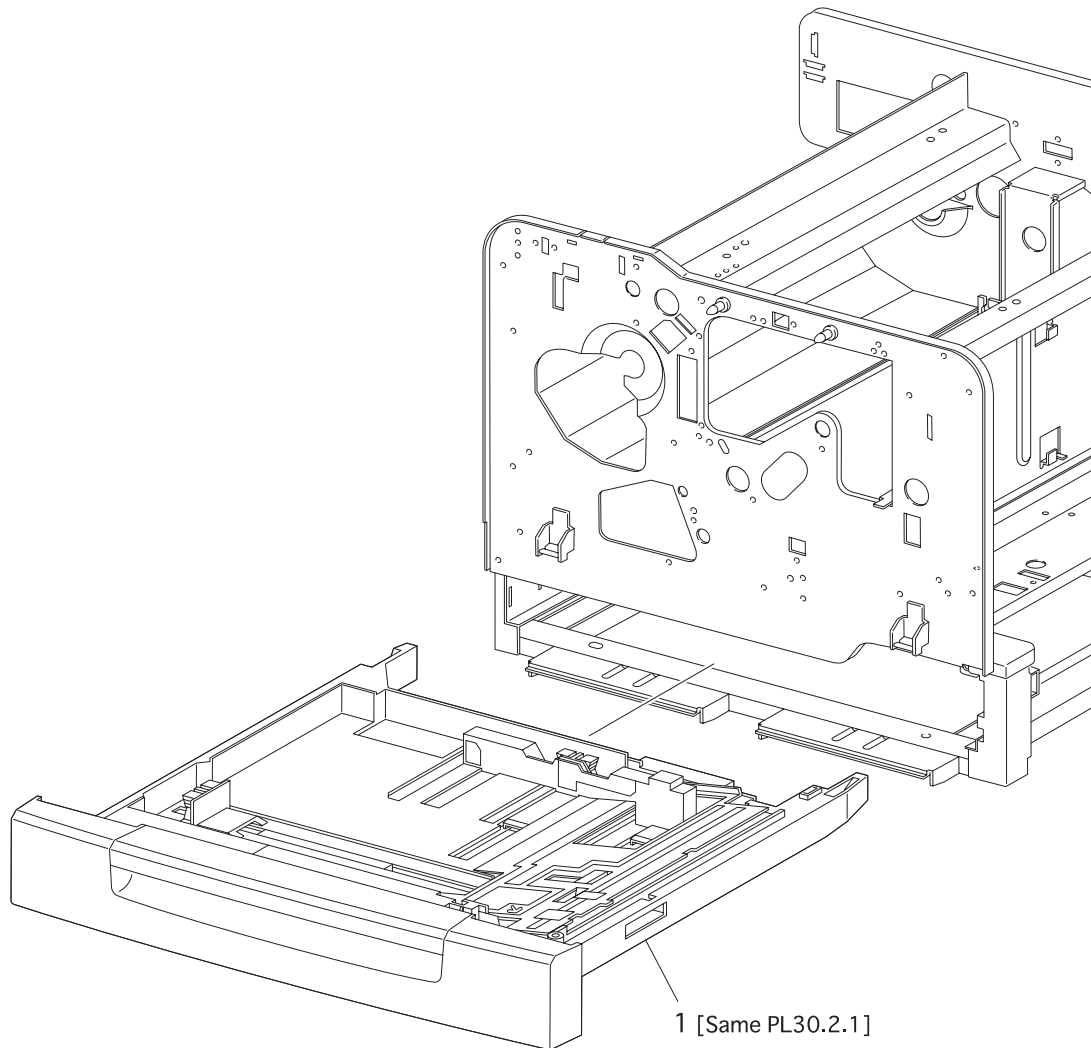
PL30.1 Option Tray I

1. OVERSIZE TRAY [same as PL30.2.1].....P/N 1710318-001

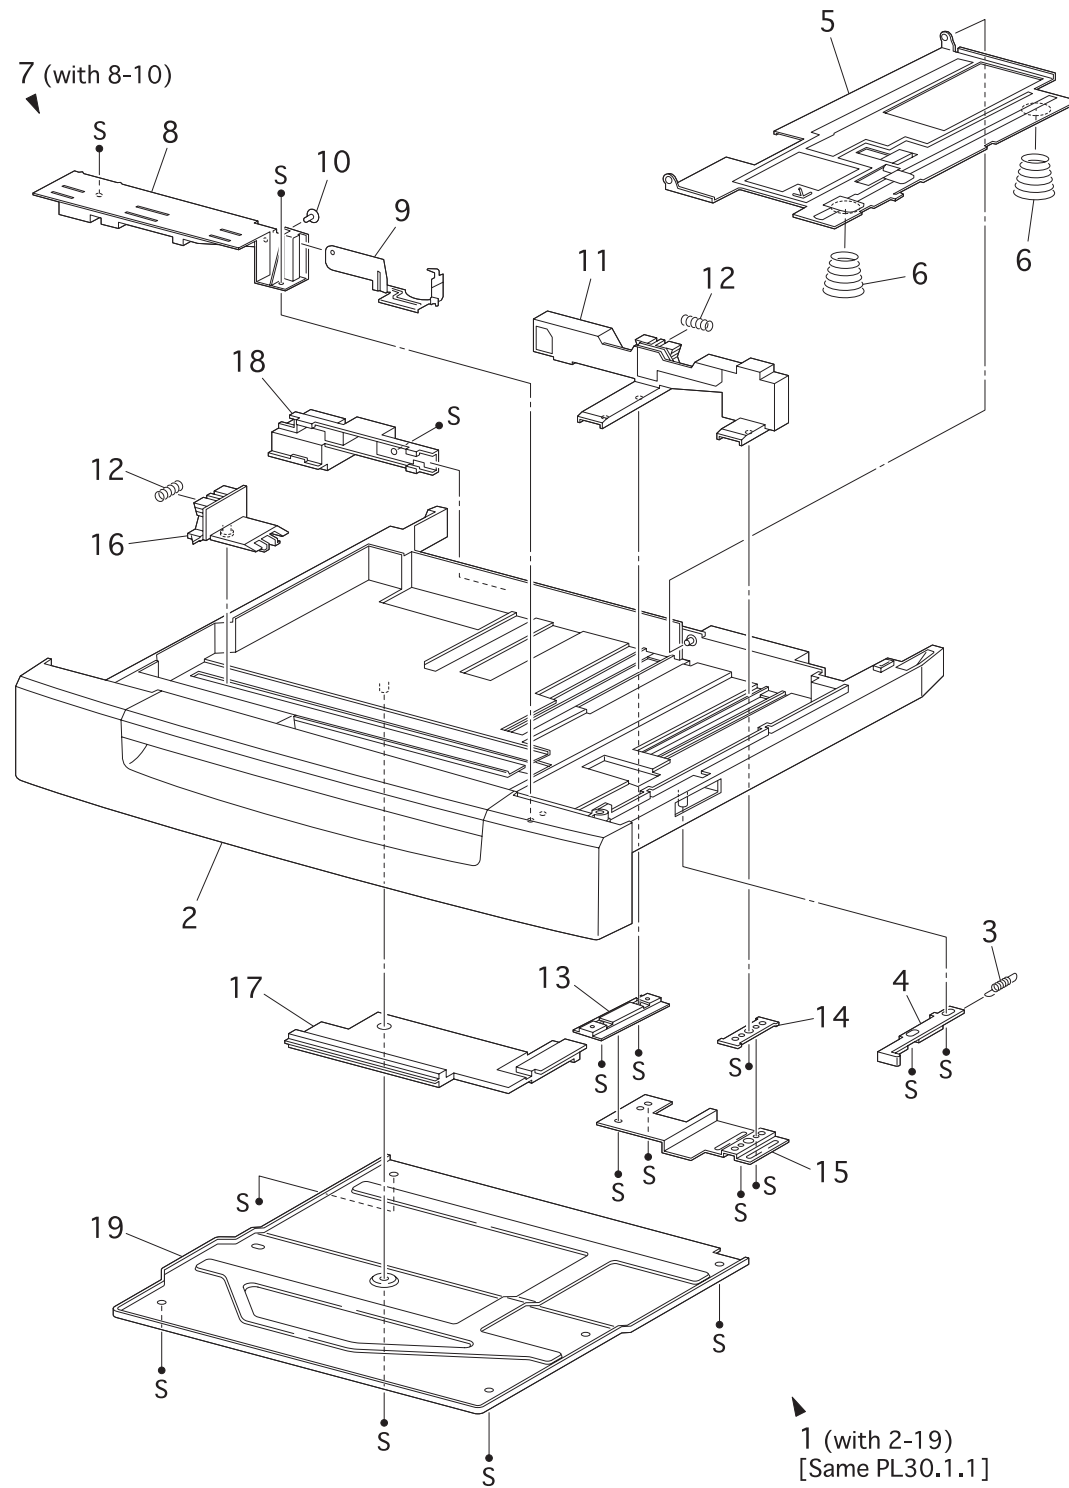
PL30.2 Option Tray II
